TENNESSEE STATE DEPT OF CONSERVATION NASHVILLE DIV 0--ETC F/6 13/13
NATIONAL PROGRAM OF INSPECTION OF NON-FEDERAL DAMS, TENNESSEE. --ETC(U)
SEP 81 W E BUSH

<table><tr> <td>Dams</td> <td>Sumner County, TN</td> </tr><tr> <td>Portland City Lake Dam, TN</td> <td>Structural Analysis</td> </tr></table>

PHASE I INSPECTION
PORTLAND CITY LAKE DAM
SUMNER COUNTY, TENNESSEE

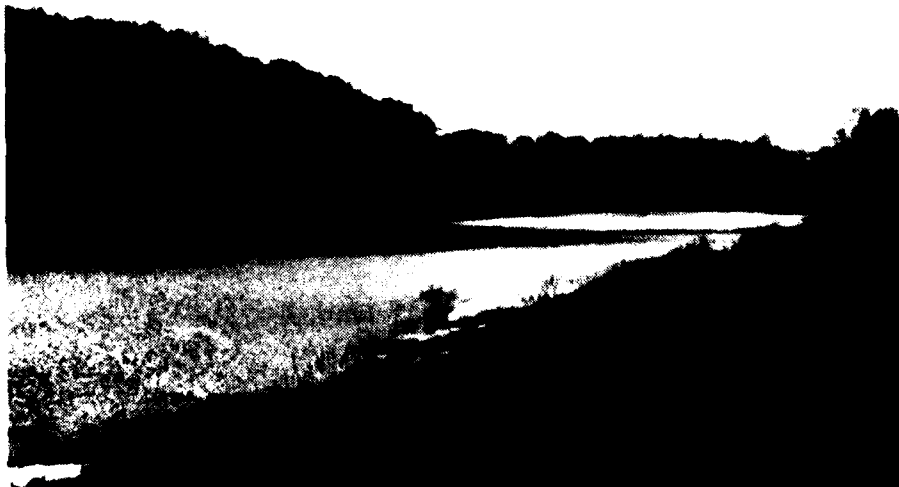
12. Portland City Lake.

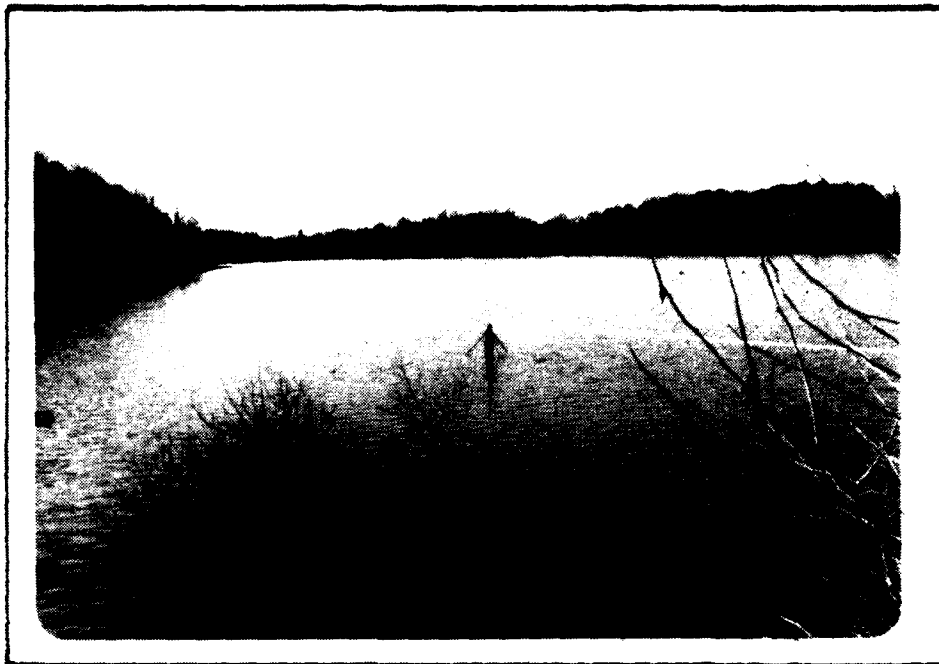
PHOTO NO. 1

- Photo No. 1 - View of the upstream face of the dam.
- Photo No. 2 - View of the downstream face.
- Photo No. 3 - View of the gate-lift structure for the water supply pipes.
